SR 308 MP 2.16 Unnamed Tributary to Liberty Bay (991000): Preliminary Hydraulic Design Report

The proposed project will replace the existing 114-foot-long, 30-inch-diameter concrete culvert with a structure designed to accommodate a minimum hydraulic width of 20 feet. The proposed structure is designed to meet the requirements of the federal injunction using the confined bridge design criteria as described in the 2013 WDFW Water Crossing Design Guidelines (WCDG) (Barnard et al. 2013). This design also meets the requirements of the WSDOT Hydraulics Manual (WSDOT 2022a).

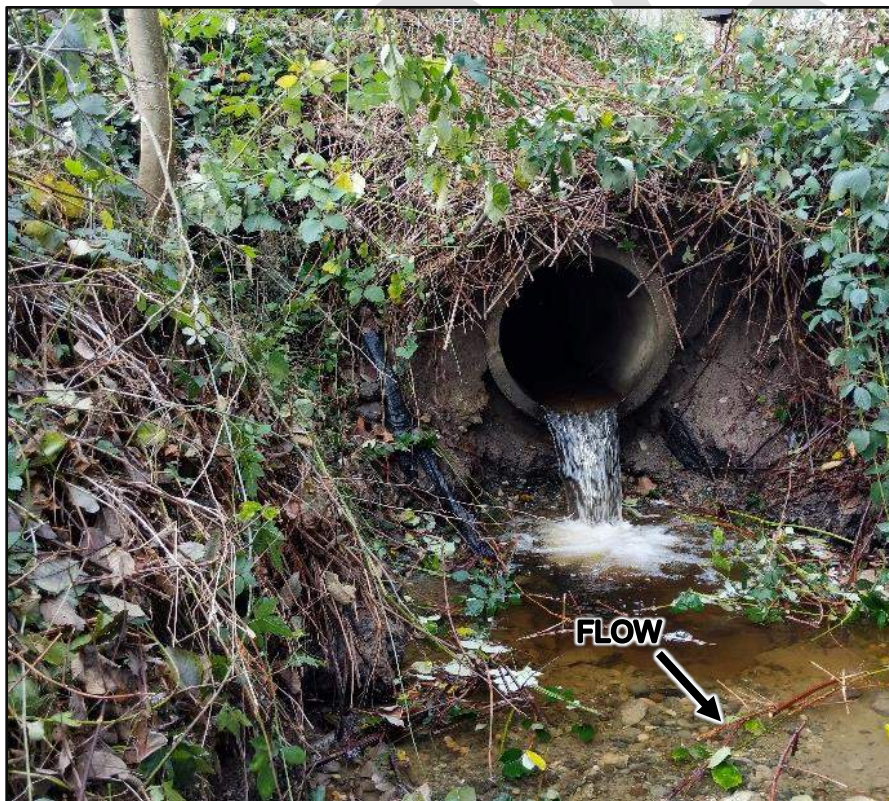
Figure 11. Culvert outlet (Sta. 2+50)

There is a 1.5-foot drop on the downstream end of the culvert along with a circular scour hole that is approximately 6 feet in diameter (see Figure 11). The bottom of the scour hole is approximately 0.5 foot below the surrounding channel bed. Aside from the scour hole, no significant pools were observed in this reach. The downstream end of the crossing is more restricted than the upstream end due to adjacent infrastructure. There is a cluster of utility boxes along the road embankment, far up the right bank of the creek channel, and a house within 50 feet of the left top of bank. The vegetation at the downstream end provides less canopy cover than upstream, and the channel is also straighter on the downstream end of the crossing (see Figure 12). The landowners on the downstream end of the crossing have installed some riparian plantings along an incised streambank adjacent to their property. This bank erosion is caused by a mid-channel stump that is redirecting flow towards the left bank (see Figure 13). The WSDOT survey crews recently removed some of the dense undergrowth that was encroaching into the channel to improve sightlines and site access.

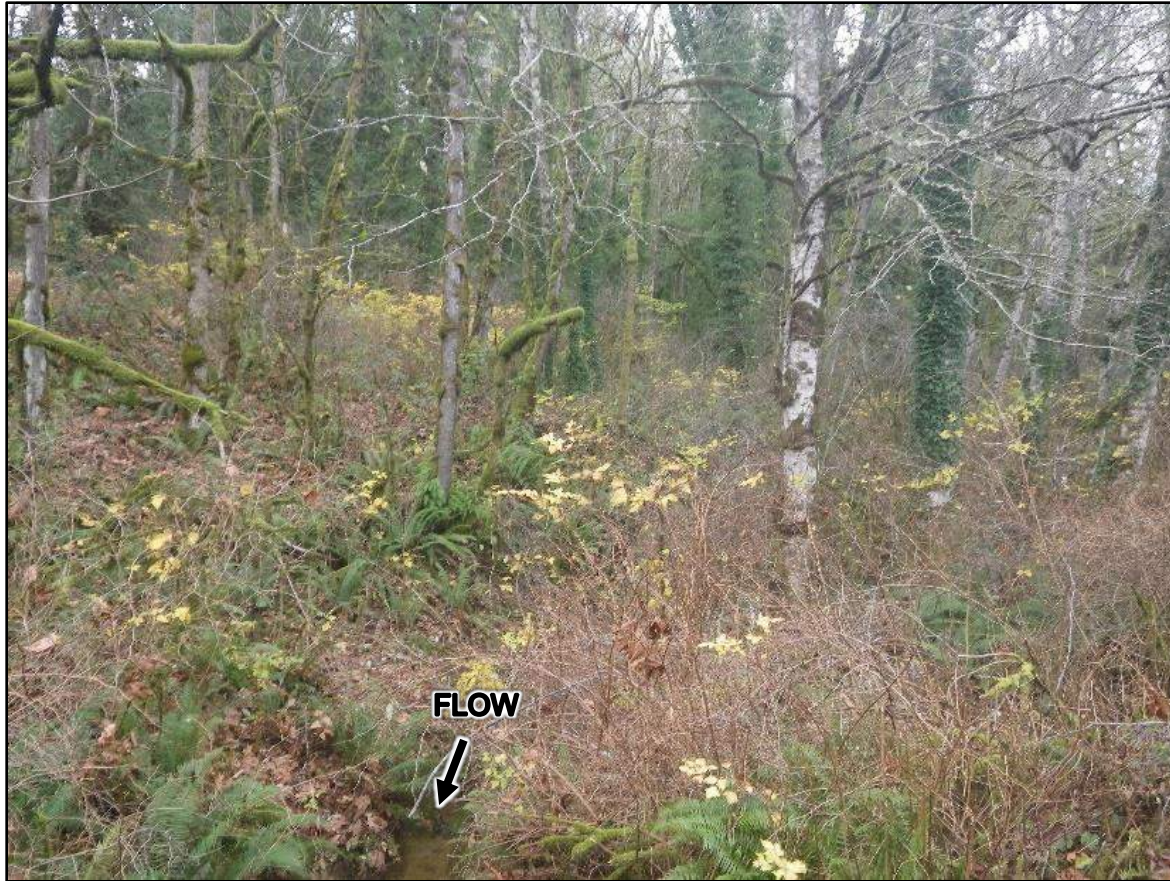
Upstream of the culvert, the riparian area consists of mid-sized deciduous trees, including black cottonwood (*Populus trichocarpa*), bigleaf maple (*Acer macrophyllum*), and red alder (*Alnus rubra*). A moderately dense shrubby understory of native vegetation, including salmonberry (*Rubus spectabilis*) and swordfern (*Polystichum munitum*), provides 75 percent cover to the stream channel and a source of woody material for channel stability and habitat diversity. English ivy (*Hedera helix*) was observed growing on a number of mature trees but was the only invasive species observed during the site visit (see Figure 14). The LWM is not likely to be transported due to the sinuosity and small size of this stream. Though woody material is present, the site visit did not discover any woody material larger than 12 inches in diameter within the stream. Future LWM recruitment through fallen tree branches and trees is possible, though no obvious candidates were observed. The number of pools is very limited, though undercut banks can provide refuge (see Section 2.6.3). The December 1, 2021, site visit did not note any beaver activity.

Figure 14: Riparian vegetation upstream (Sta. 3+80)

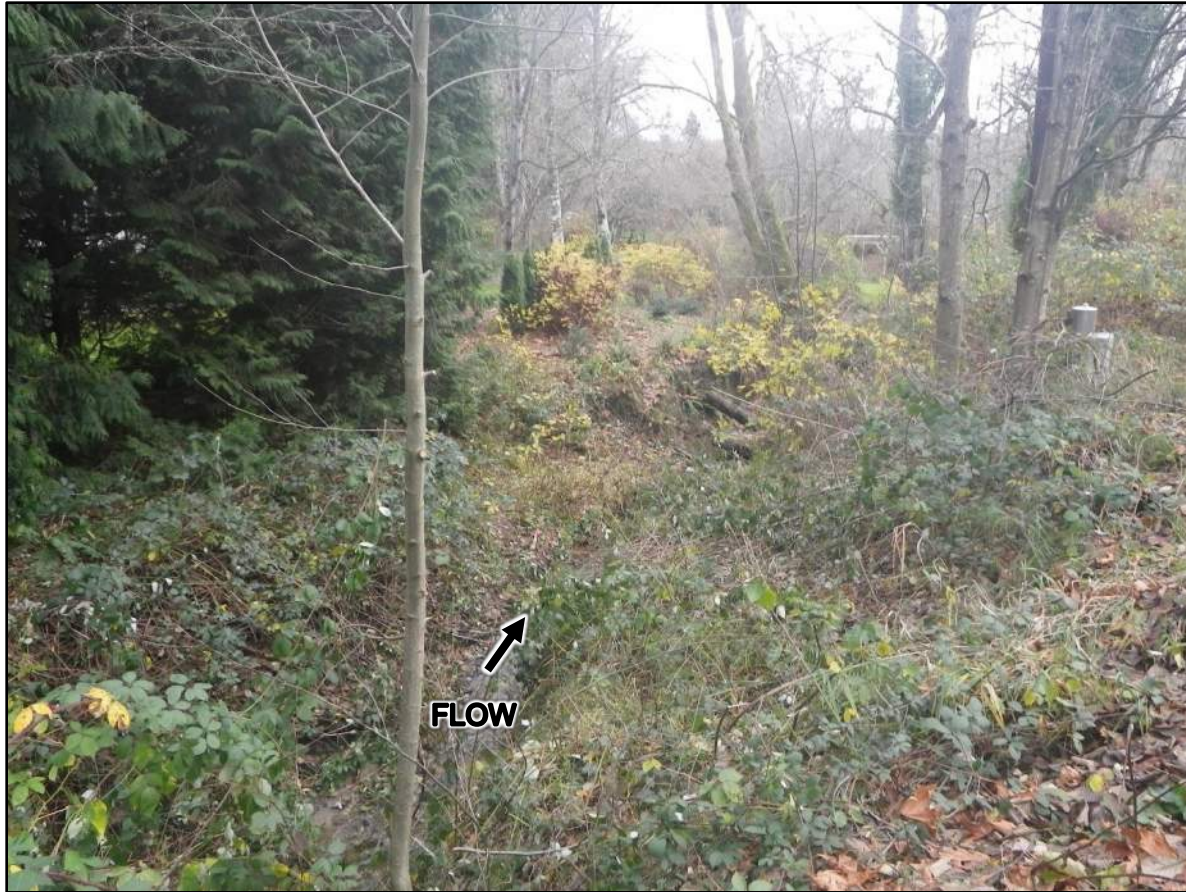
Downstream of the culvert, the riparian area has been highly modified with lawn, pasture, and other landscaping, and the stream is less shaded than upstream. In this reach, riparian vegetation consisting of bigleaf maple, red alder, and western redcedar (*Thuja plicata*) trees provide shade only for approximately 15 percent of the stream (see Figure 15). Salmonberry, swordfern, trailing blackberry (*Rubus ursinus*), and Himalayan blackberry is the predominate understory vegetation and provide minimal stream cover outside the immediate vicinity of the culvert and roadway. English ivy was also observed growing on mature trees within the downstream reach. A mid-channel rootwad 100 feet downstream of the culvert is redirecting the stream and causing erosion on the left bank. The rootwad does provide an area of refuge for migrating adult salmonids and for rearing juvenile salmonids during higher flows, but it does not interact with the low-flow channel sufficiently to provide primary habitat.

Figure 15: Riparian vegetation downstream (Sta. 2+50)

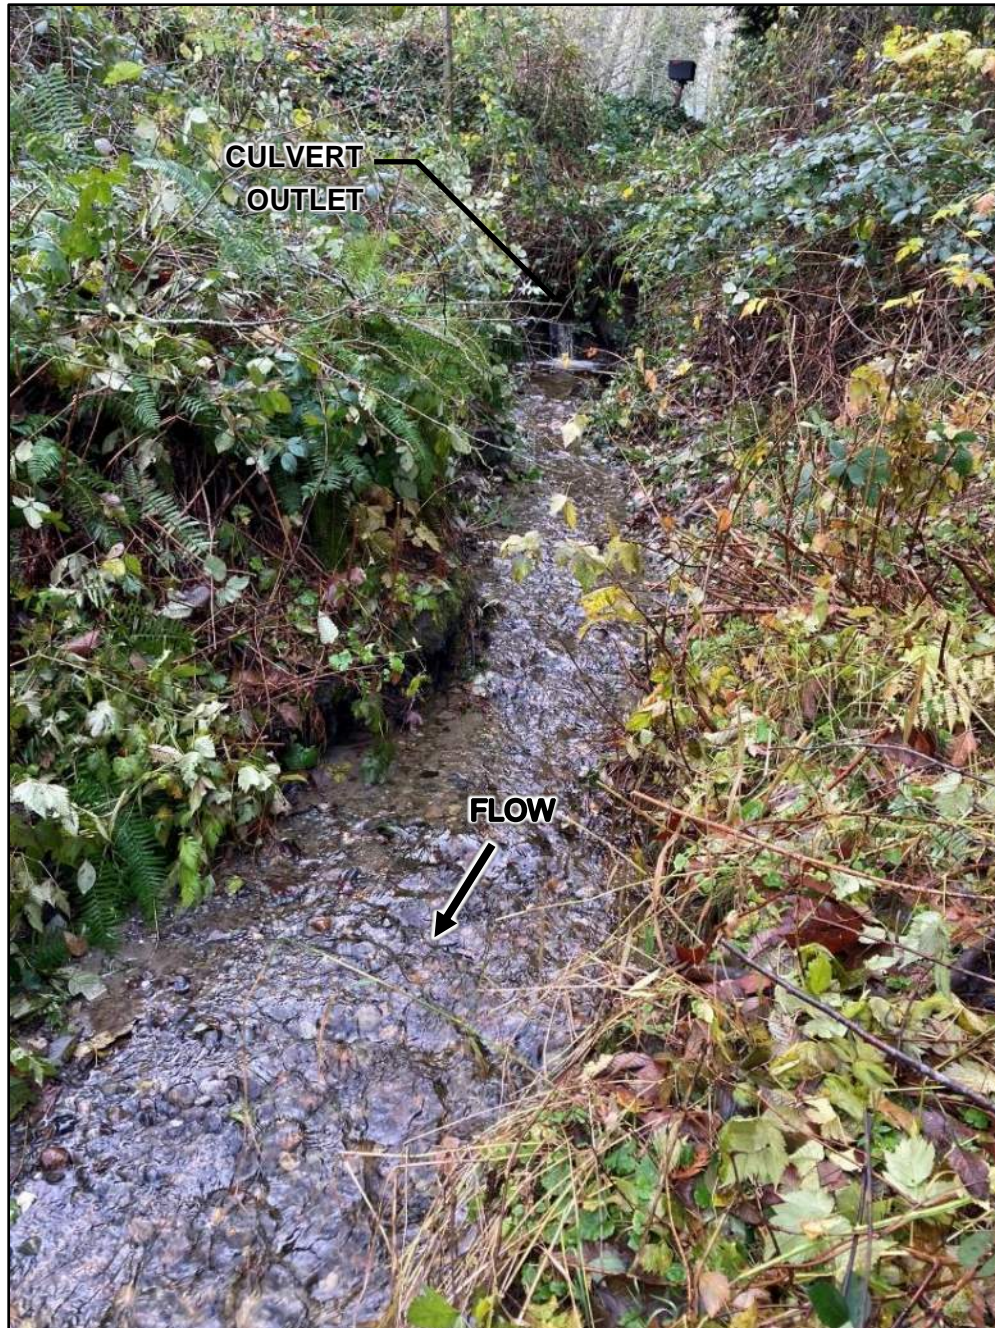
Figure 19: Channel downstream of culvert is straight, with steep banks, and is incised approximately 1.5 feet to 2 feet (Sta. 2+25)

The channel downstream of the culvert is not suitable for a reference reach based on evidence of scour, bank erosion, and channel incision directly downstream of the culvert for about 200 feet (see Figure 19) that may have been caused by channel modifications from adjacent landowners that straightened the channel. Farther downstream, the channel exhibits less incision but also appears to have been widened as a result of human activities.

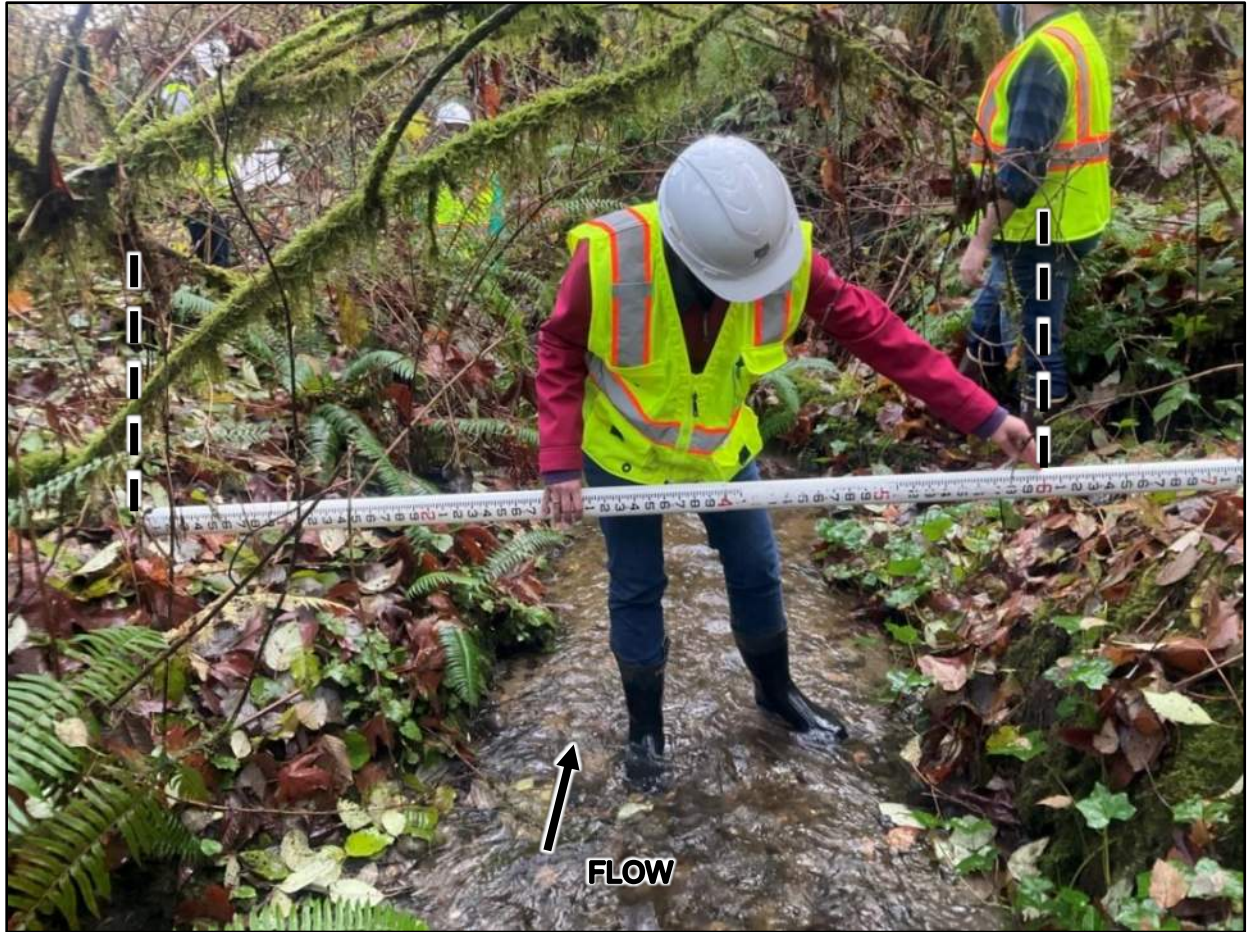
The stream assessment initially included four BFW measurements in the assessed reach, two of which were within the reference reach. Figure 20 and Figure 21 show the two BFW measurements within the reference reach, which the co-managers agreed upon.

Figure 20: BFW-3 measurement of 6 feet measured within the reference reach approximately 60 feet upstream of the culvert (Sta. 4+15)

Table 3 summarizes the BFW measurements, which range from 4.5 feet to 8.5 feet. The measured BFWs were discussed with the co-managers during the site visit on December 17, 2021. The co-managers did not concur with one of the initial BFW measurements within the reference reach (BFW-2), which was excluded from the BFW average because it was under the influence of the existing culvert. The co-managers added two additional BFW measurements beyond the reference reach (BFW-5 and BFW-6) for inclusion in the BFW average (see Figure 7 in Section 2.6.1 for a map that shows the BFW measurement locations). The inclusion of these new measurements increased the average BFW to 7.3 feet. However, during the site visit the co-managers preferred an average BFW of 7.5 feet. This average BFW measurement is used to size the minimum hydraulic opening and determine the proposed channel width for the project. With an average bankfull depth of 1.2 feet, the bankfull width-to-depth ratio is approximately 6.25. Figure 22 shows the surveyed channel cross sections at all of the BFW measurement locations included in the BFW average.

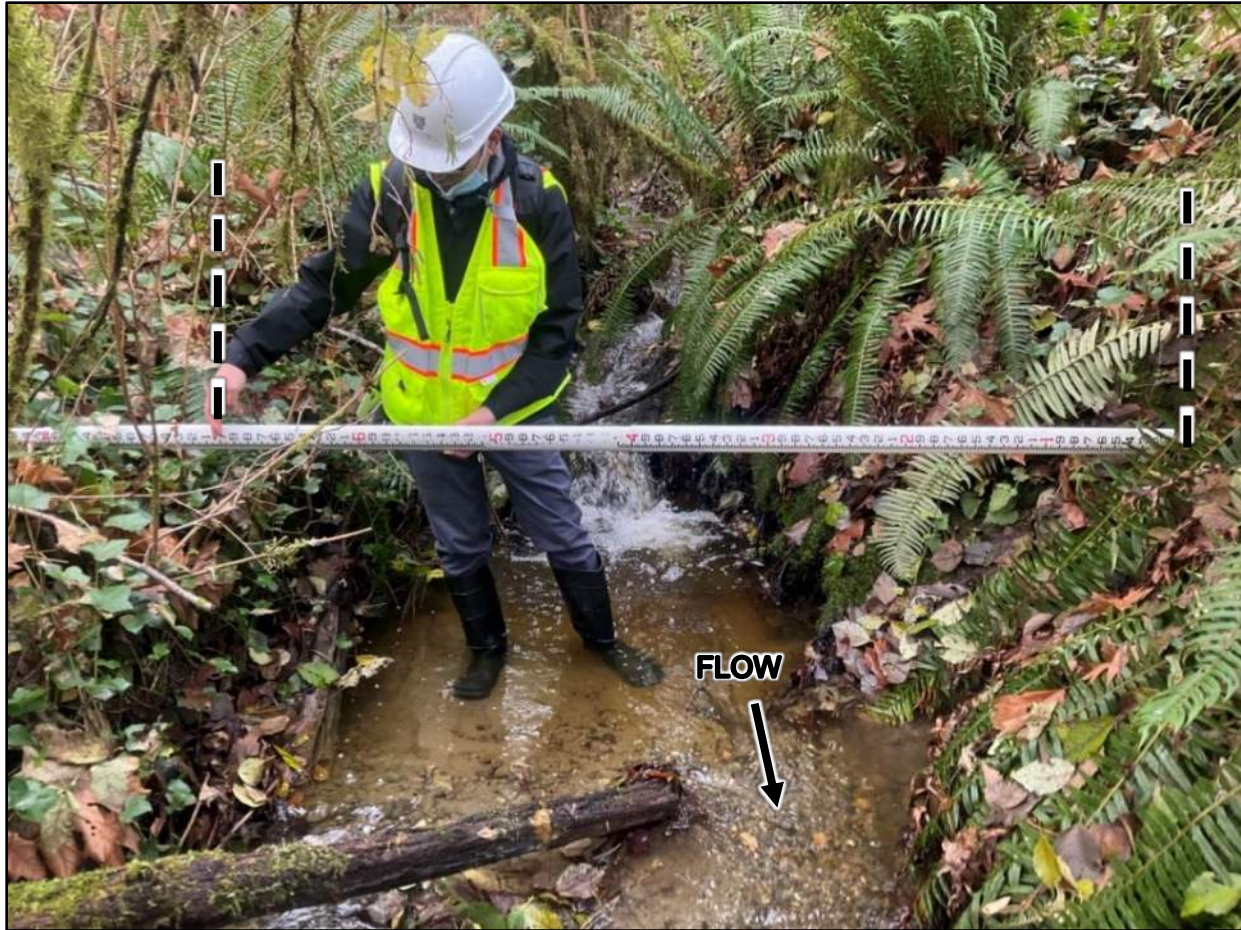
Figure 21: BFW-4 measurement of 7 feet measured within the reference reach approximately 125 feet upstream of the culvert (Sta. 5+00)

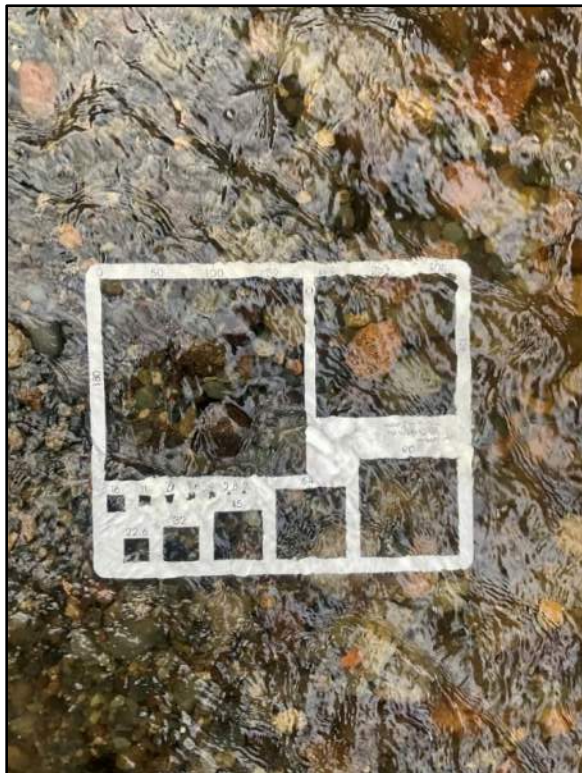
Figure 24. PC-1 sediment with gravelometer

PC-1 was conducted along a length of stream approximately 30 feet and 50 feet downstream of the existing culvert outlet. The sediment here consisted of coarse sands, gravels, and small cobbles of 3.5 inches or less (see Figure 24 and Figure 25). In general, the coarse material at this location was more exposed than within the reference reach, where much of the coarser material was overlain with sand.

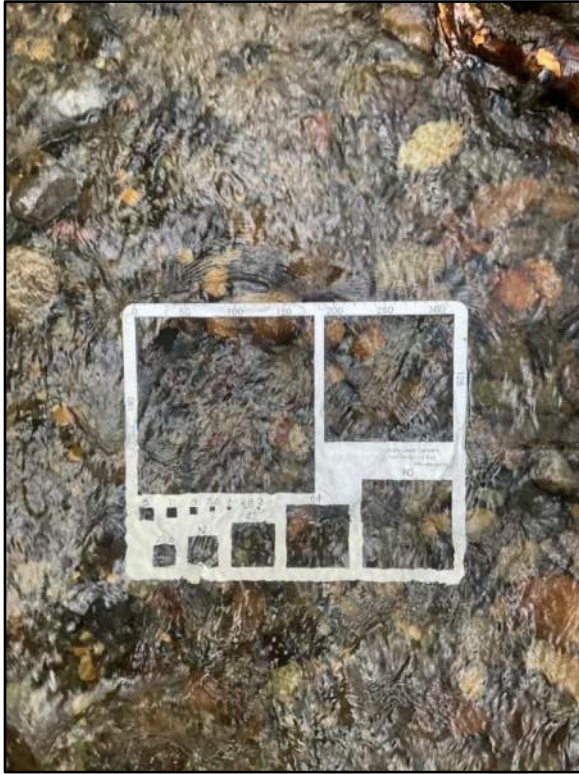
Figure 26. PC-2 sediment with gravelometer

PC-2 was conducted within the reference reach, at a location approximately 55 feet to 65 feet upstream of the existing culvert inlet. This location exhibited a gravel and cobble plane-bed morphology with few fines. The sediment here consisted of coarse sands, gravels, and small cobbles of 2.5 inches or less (Figure 26 and Figure 27). The coarse material was overlain with sand in much of the reference reach.

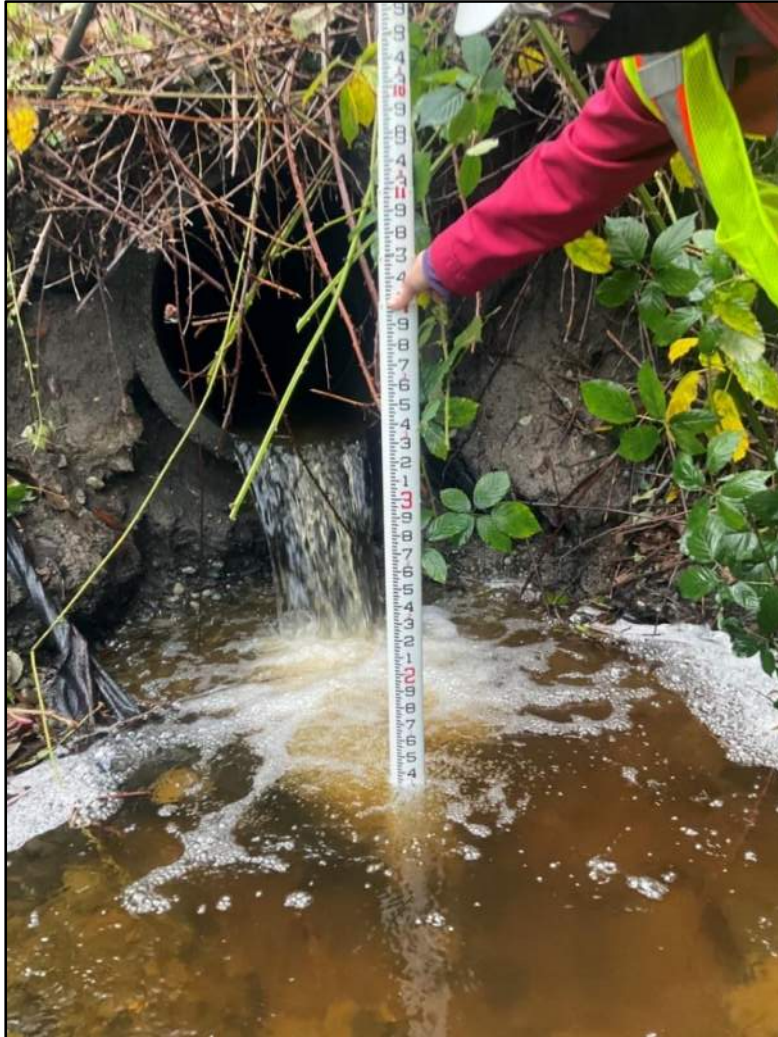
Figure 30: Scour hole at downstream end of culvert (Sta. 2+55)

Section 4.1.3 discusses the proposed longitudinal profile in the reconstructed stream section, which will remove the drop at the downstream end of the existing structure. This design will minimize the probability of long-term vertical instability. See Section 7.2 for a more detailed discussion of long-term vertical channel stability.

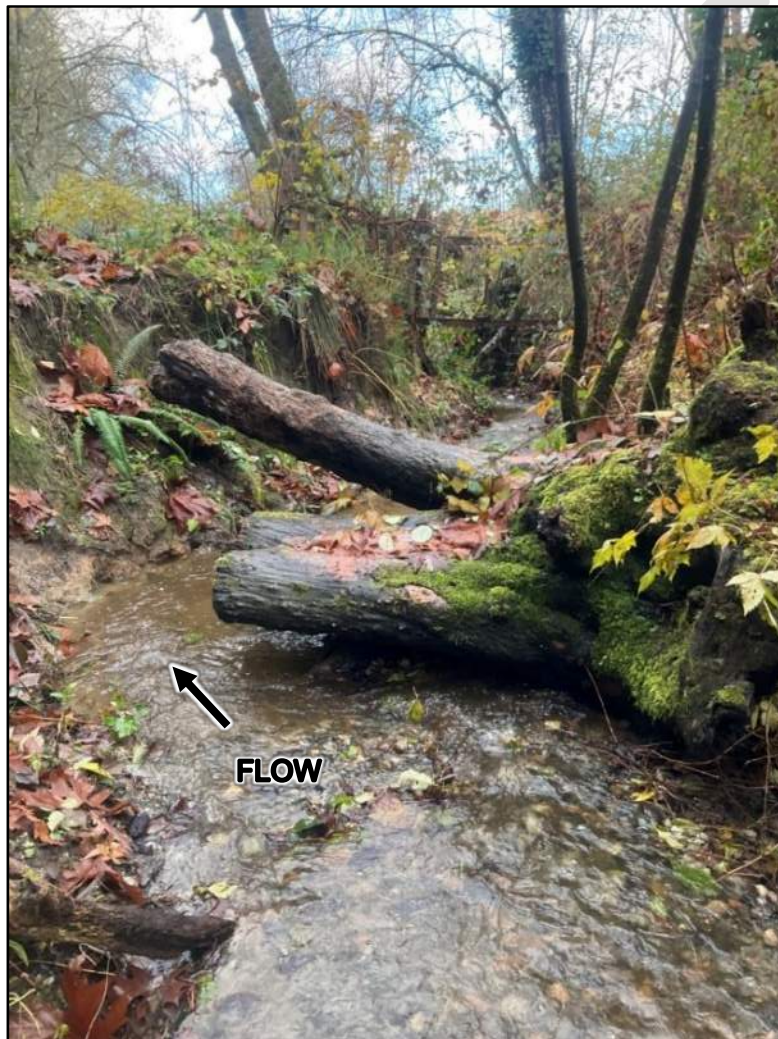
The channel downstream of the existing culvert has steep exposed banks. Evidence of channel widening and lateral erosion was limited to a location in the downstream reach where a large stump had created a flow obstruction (see Figure 31). Except for this one location of erosion, the channel banks do not appear to be actively eroding. The project-specific geotechnical scoping memo clarifies that the underlying soils at this site are cohesionless and highly susceptible to erosion.

Figure 31: Channel widening and bank erosion due to flow obstruction (Sta. 2+00)

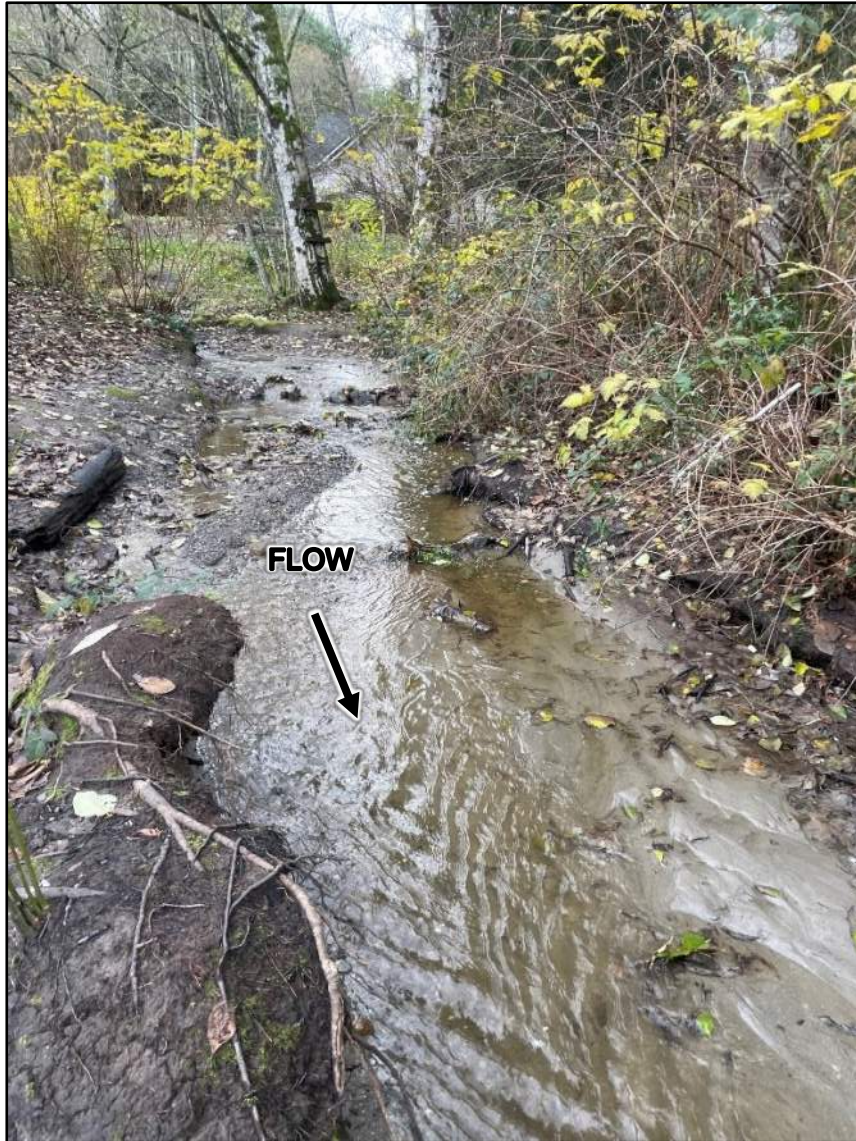
Figure 32: Over-widened channel approximately 250 feet downstream of the culvert (Sta. 0+00)

Approximately 250 feet downstream of the culvert, the channel appears over-widened (see Figure 32), likely the result of the lack of riparian vegetation and bank erosion from use by stock animals. This over-widening does not appear to be a result of natural channel migration but rather of damage to the stream buffer and banks from landowner activity.

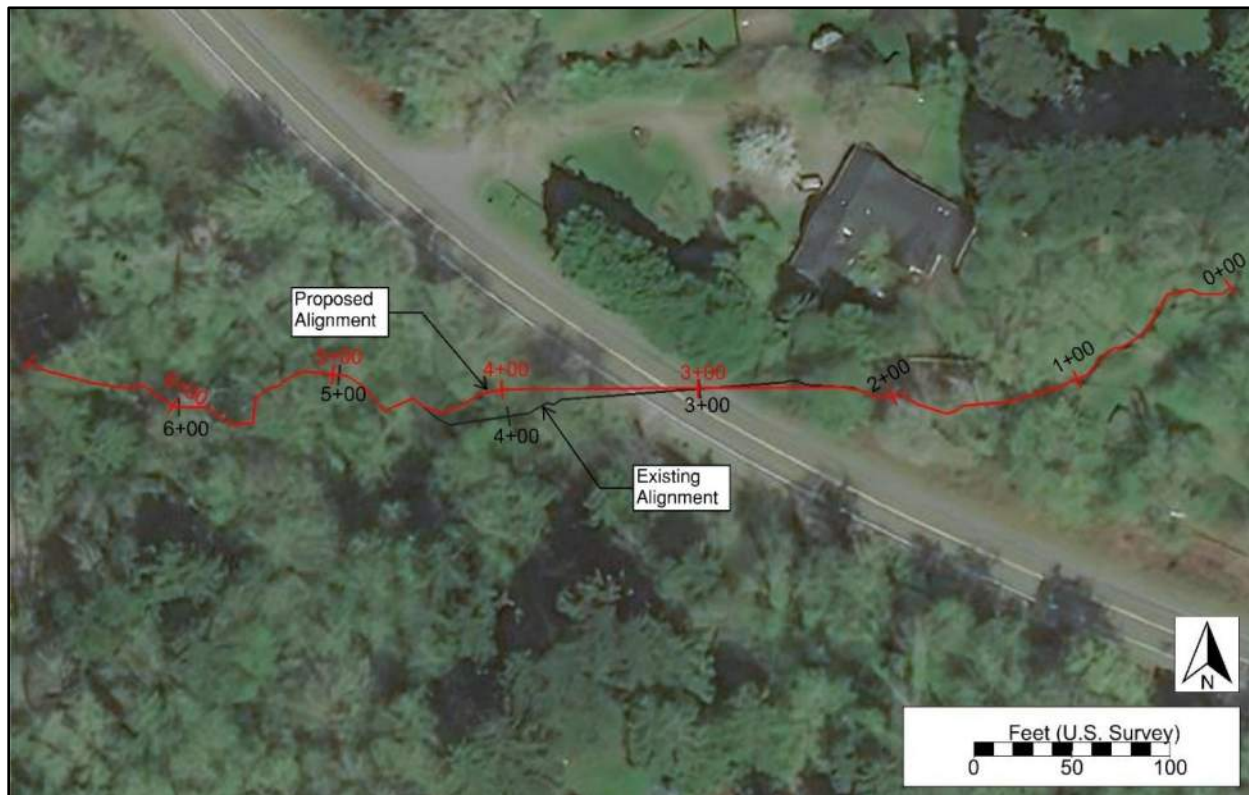
Figure 36: Existing and proposed stream alignments

The proposed channel includes a realignment at the upstream end of the existing culvert so that the downstream end of the proposed structure will be directed away from the channel banks adjacent to the downstream property. The co-managers proposed this realignment during the December 17, 2021, site visit. The proposed length of reconstruction is 225 feet, from station 2+25 to station 4+50 (see Figure 36). This realignment will result in a 3-foot loss of stream length compared to the existing alignment. Considering the total length of reconstruction and the habitat gained by creating a channel within the proposed structure, this loss of stream length is negligible.

The proposed alignment will tie into the existing alignment approximately 40 feet downstream of existing culvert outlet and approximately 77 feet upstream of the existing culvert inlet. The proposed realignment will result in a 4-degree increase in skew with respect to the roadway and will be straight for approximately 172 feet, both within the culvert and on both the upstream and the downstream ends of the culvert. This design will align the flow with the structure at the entrance and exits of the proposed structure and minimize potential for lateral migration and scour. The proposed realignment at the upstream end of the culvert also will be beneficial for construction because the steep hillslope along the right bank at the upstream end of the existing culvert would be challenging for construction access and grading options. The proposed realignment will move the upstream end of the proposed structure farther away from this hillslope. The existing channel at the upstream end of the proposed realignment will be filled or reverse graded to drain into the proposed channel and thus minimize potential for erosion or lateral migration at the structure inlet, as well as to prevent fish stranding. The resulting

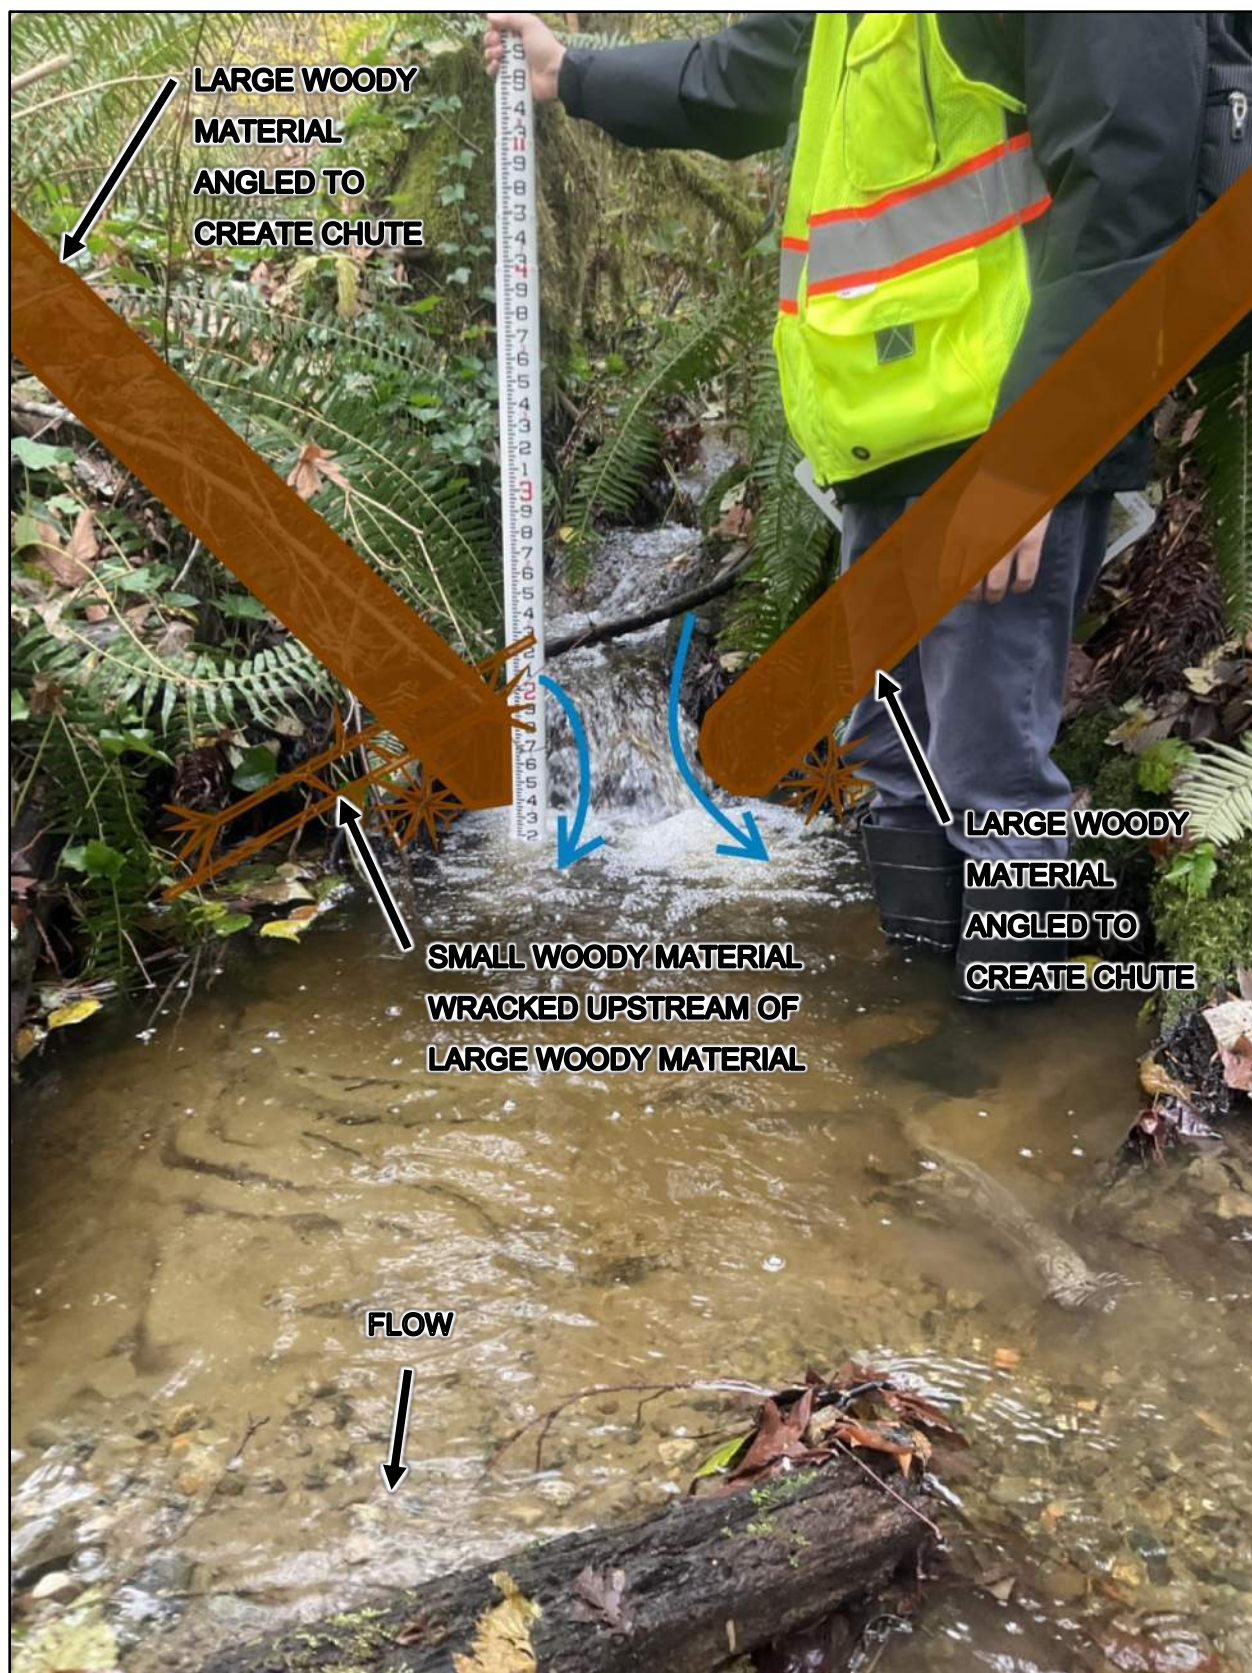
Figure 40: Wood-forced step near upstream end of reference reach (Sta. 5+25)

The reference reach exhibits a combination of gravel and cobble plane-bed sections interspersed with step-pool features forced by small woody material. The step heights are generally 6 inches or less, and are spaced approximately 25 feet to 35 feet apart (see Figure 16 and Figure 17). The small woody material does not have an impact on channel width. The pool features were filled with coarse to fine sand and very few fines. No boulders were observed during the site visit.

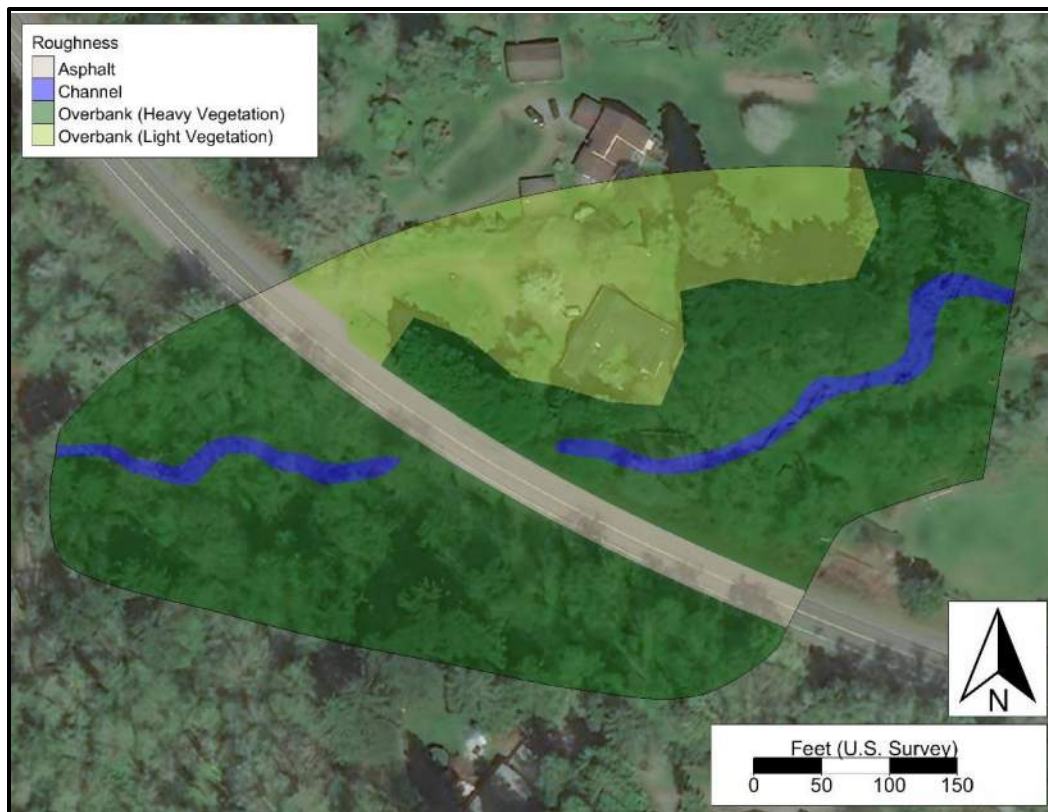
Figure 45: Spatial distribution of existing-conditions roughness values in SRH-2D model

Material	Manning's n
Asphalt	0.02
Existing channel	0.04
Overbank (heavy vegetation)	0.07
Overbank (light vegetation)	0.045
New channel (outside structure)	0.08
New channel (inside structure)	0.045

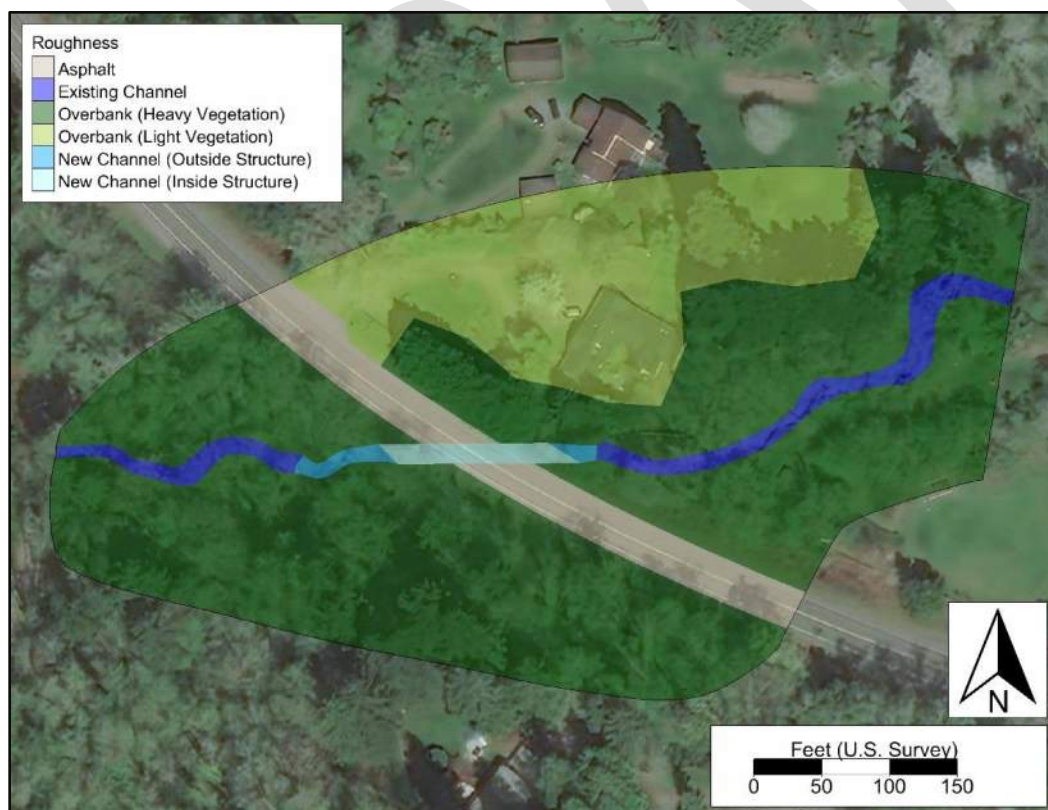
Figure 46: Spatial distribution of proposed-conditions roughness values in SRH-2D model

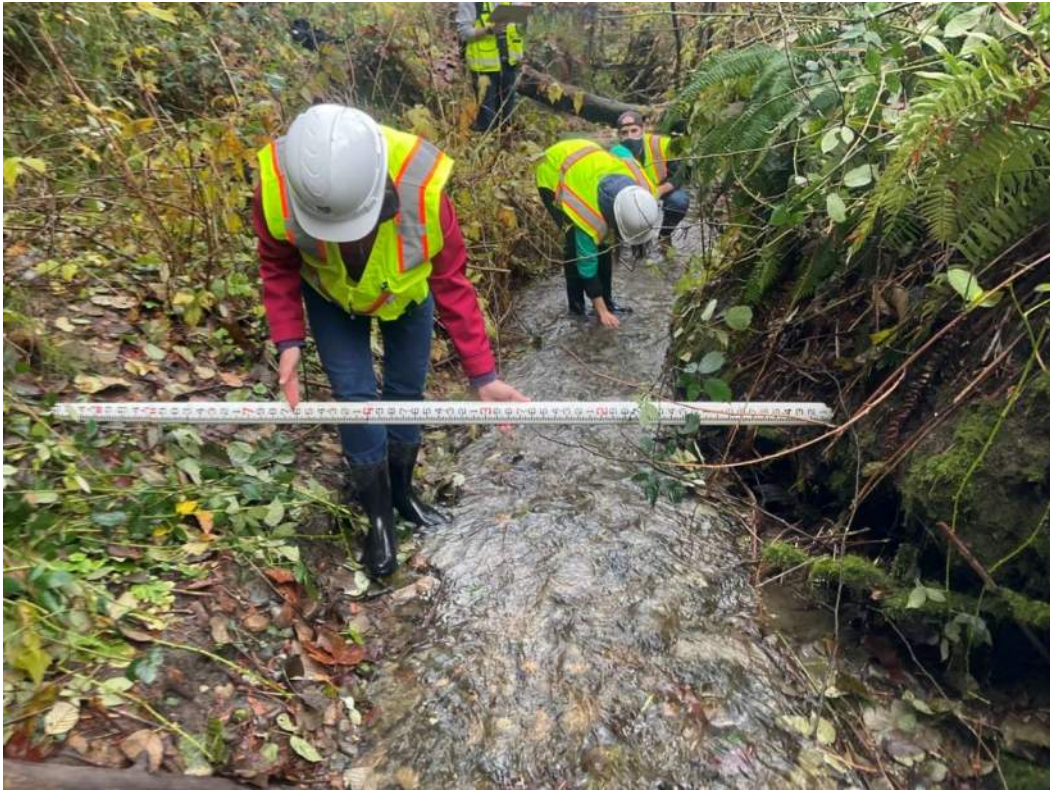
Figure 2. BFW-1 Measurement

BFW-1 was measured approximately 25 feet downstream of the culvert outlet. Measured BFW was 4.5 feet. This section of stream was modified by adjacent property owners, so the BFW was not considered in the average BFW approximation for the stream (Figure 2).

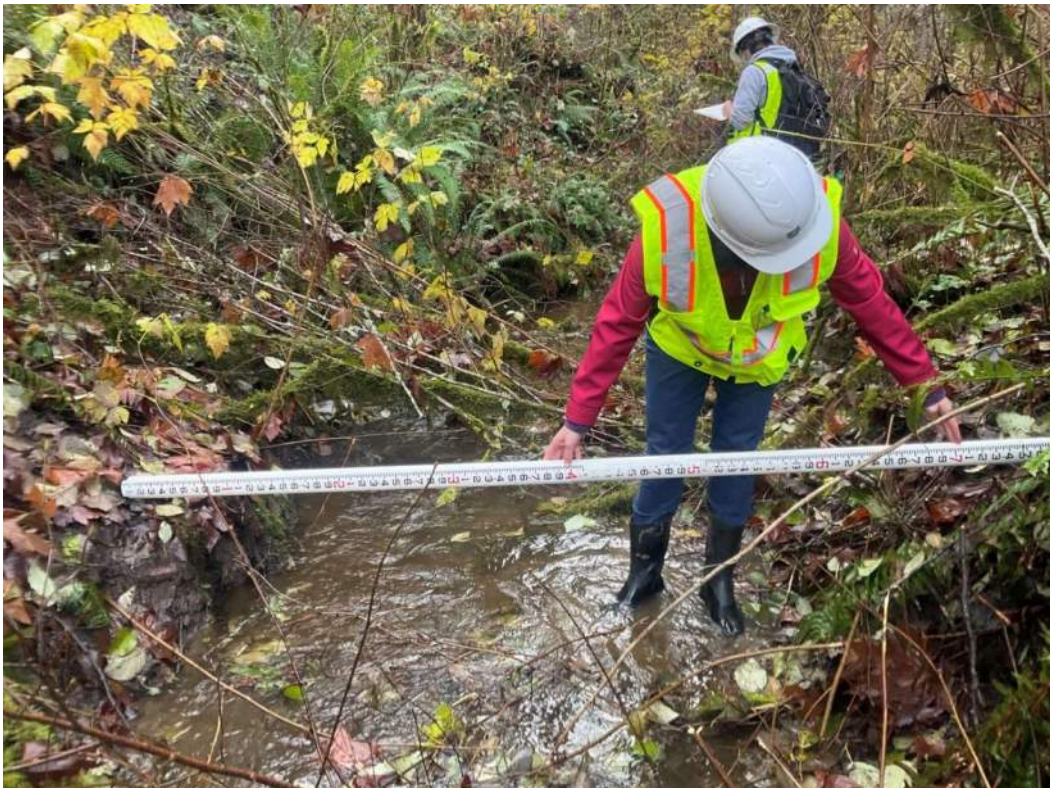
Figure 3. BFW-2 Measurement

BFW-2 was measured within the reference reach approximately 40 feet upstream of the culvert inlet. Measured BFW was 7 feet (Figure 3).

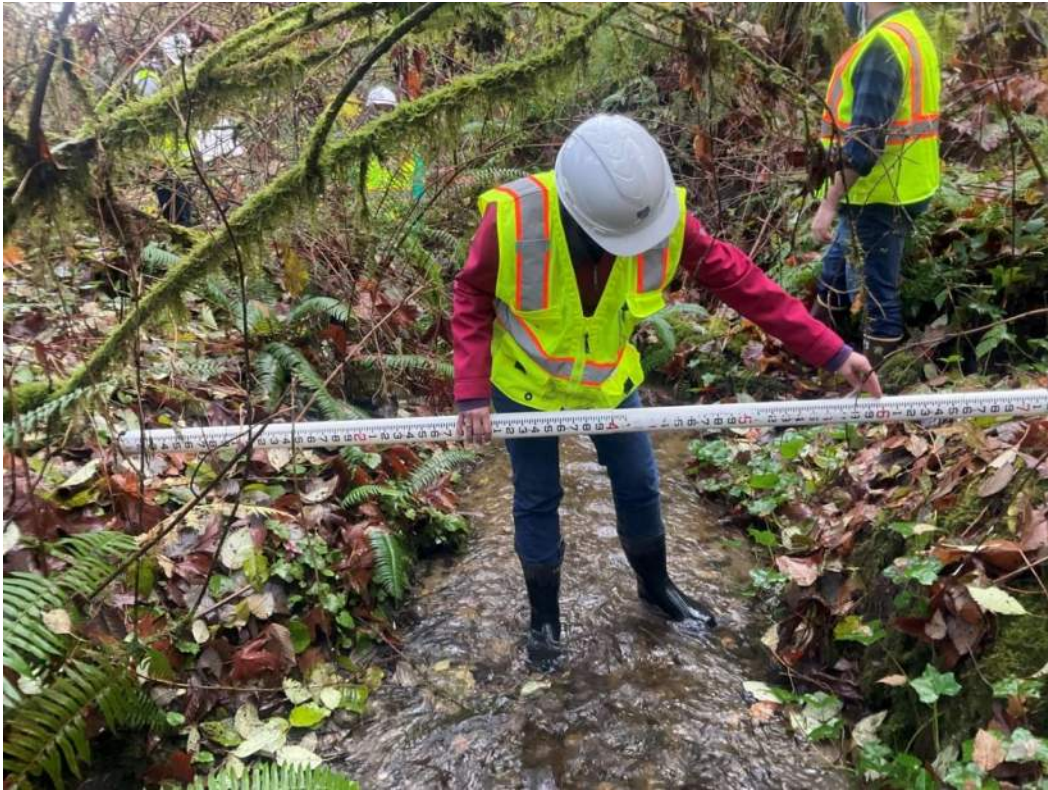
Figure 4. BW-3 Measurement

BFW-3 was measured within the reference reach approximately 60 feet upstream of the culvert inlet. Measured BFW was 6 feet (Figure 4).

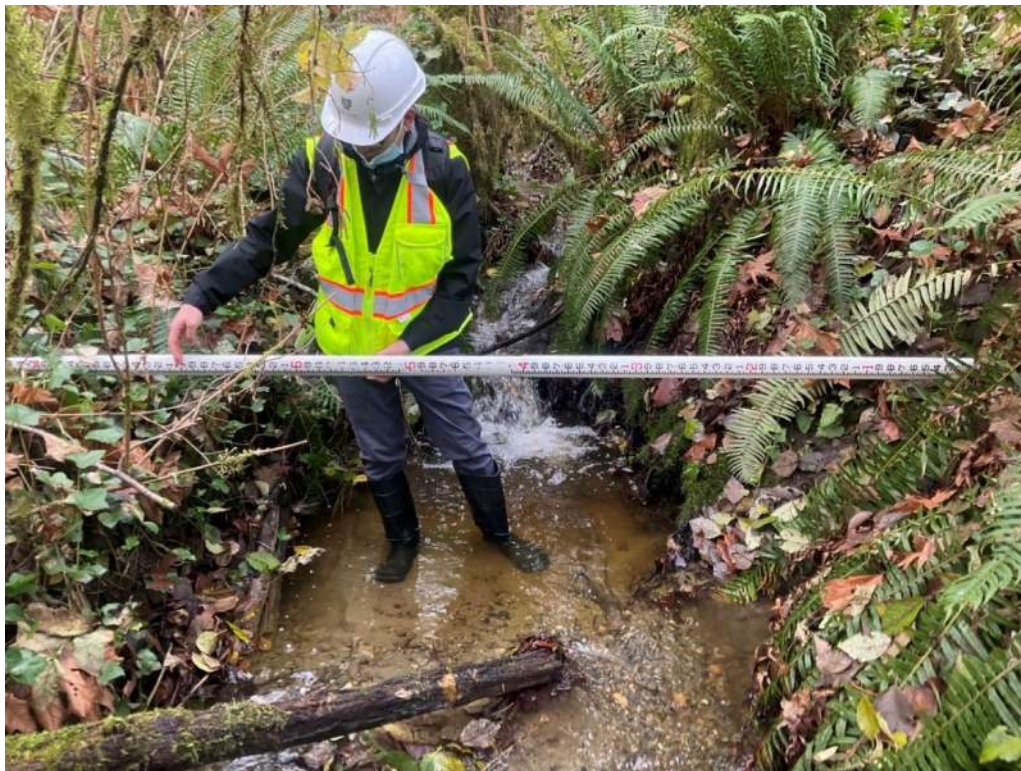
Figure 5. BFW-4 Measurement

BFW-4 was measured within the reference reach approximately 125 feet upstream of the culvert inlet. Measured BFW was 7 feet (Figure 5). This measurement was taken at the midpoint of a plunge pool downstream of a 6-inch drop in the channel. This location represents the widest expected bankfull width within the reference.

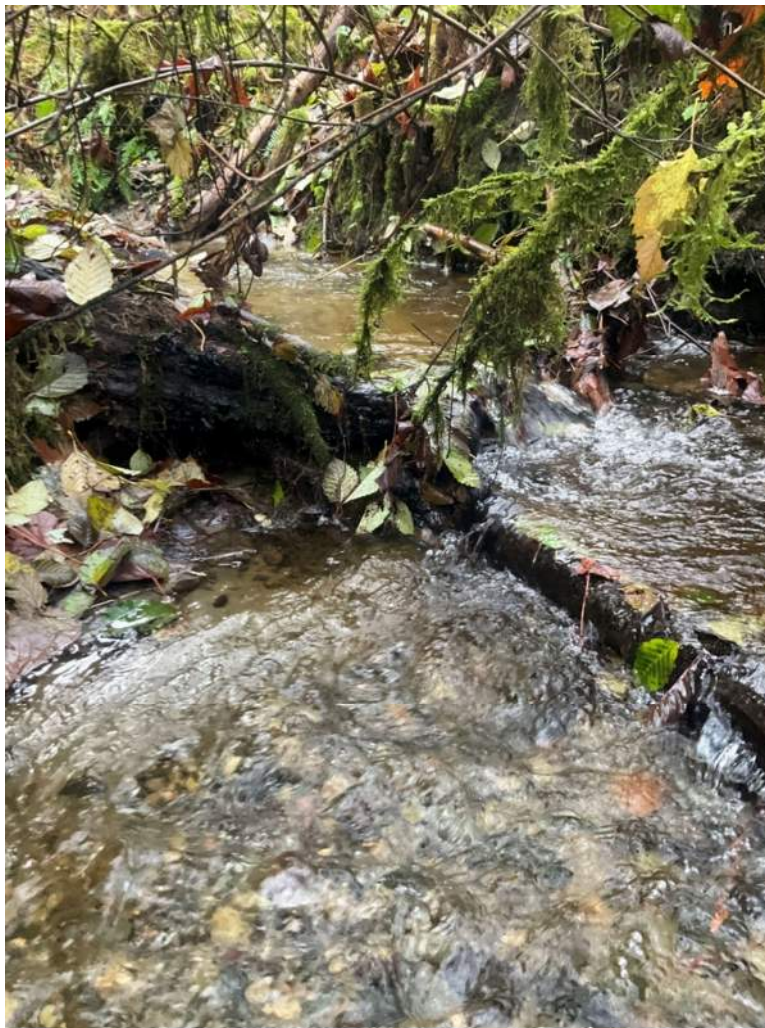
Figure 6. In-Channel Woody Debris

The reference reach exhibits a combination of gravel and cobble plane-bed sections interspersed with step-pool features caused by woody material. The step heights are generally 6 inches or less, spaced approximately 25 to 35 feet apart. The pool features were filled with coarse to fine sand with no evidence of silts (Figure 6 and Figure 7). Large boulder or bedrock steps were not observed in the field.
